Liberty Ditch Bank Stabilization

Preliminary Engineering Report

City of Killeen, Texas

February 8, 2017

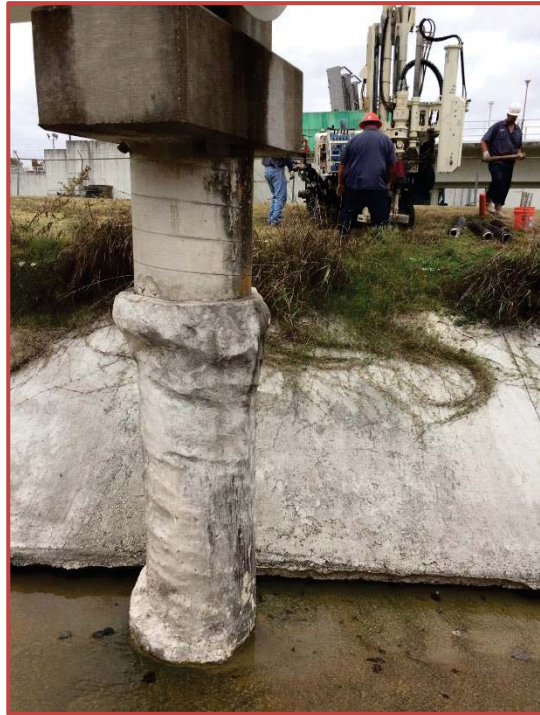
Photo 2. Boring 2.

Groundwater: Borings 1 and 3 were dry while drilling. Water was initially observed in Boring 2 at about 8 feet below ground surface (BGS), and remained at 8 feet after about 10 minutes.

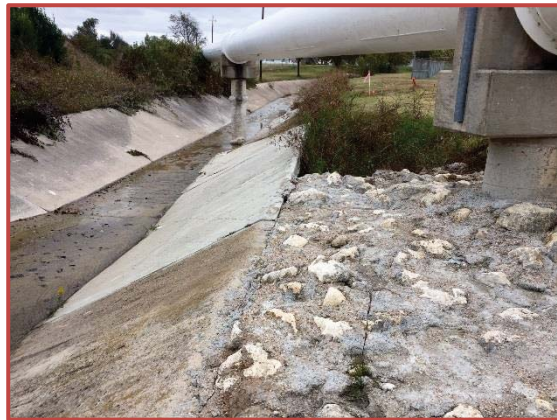
Photo 4. General Area

Project Description: A drainage channel bank section has ‘failed’ beneath an aerial pipeway, and a pier support is being remediated. The project vicinity is shown on Plate 1. The scope of services is described in Langerman Foster Engineering (LFE) proposal numbers GEO16-061R2 and R3, dated respectively November 14 and December 1, 2016.

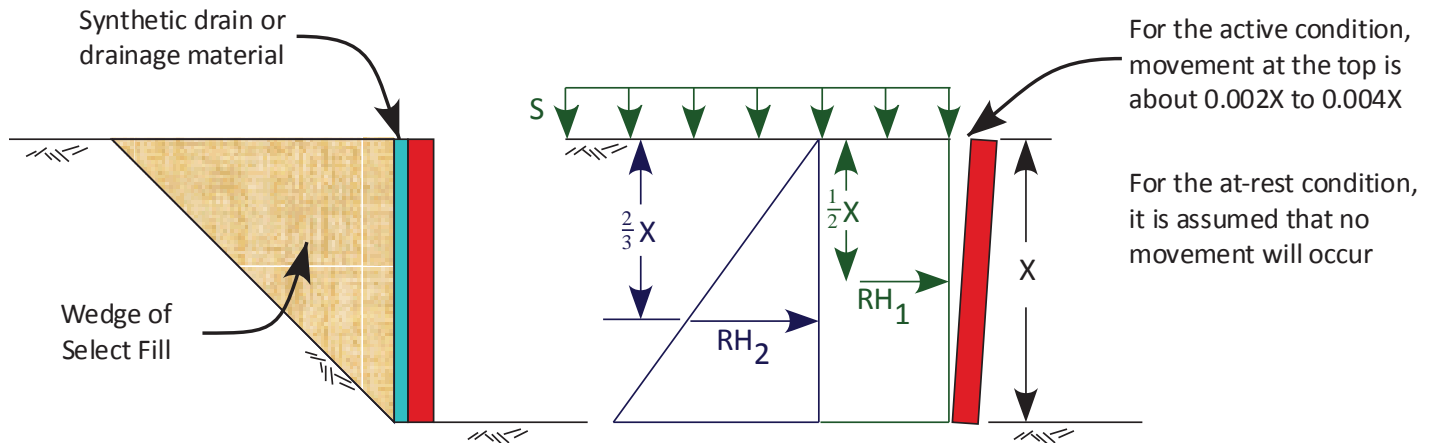
Project Information: Figure 6.1 and Table 6.1 provide information for retaining structures less than about 10 feet in height. Since the site is on a creek, the design engineer must address erosion issues. Include hydrostatic pressures in the lateral load calculations unless water such as might exist immediately after a flood event can be dissipated prior to imposing its lateral load. In our opinion, rapid draw-down conditions would exist immediately after a flood event, and hydrostatic pressures would be difficult to dissipate prior to imposing its lateral load. Table 6.1 assumes undrained conditions.
