Killeen Transfer Station Seam documentation / Seam height 3"

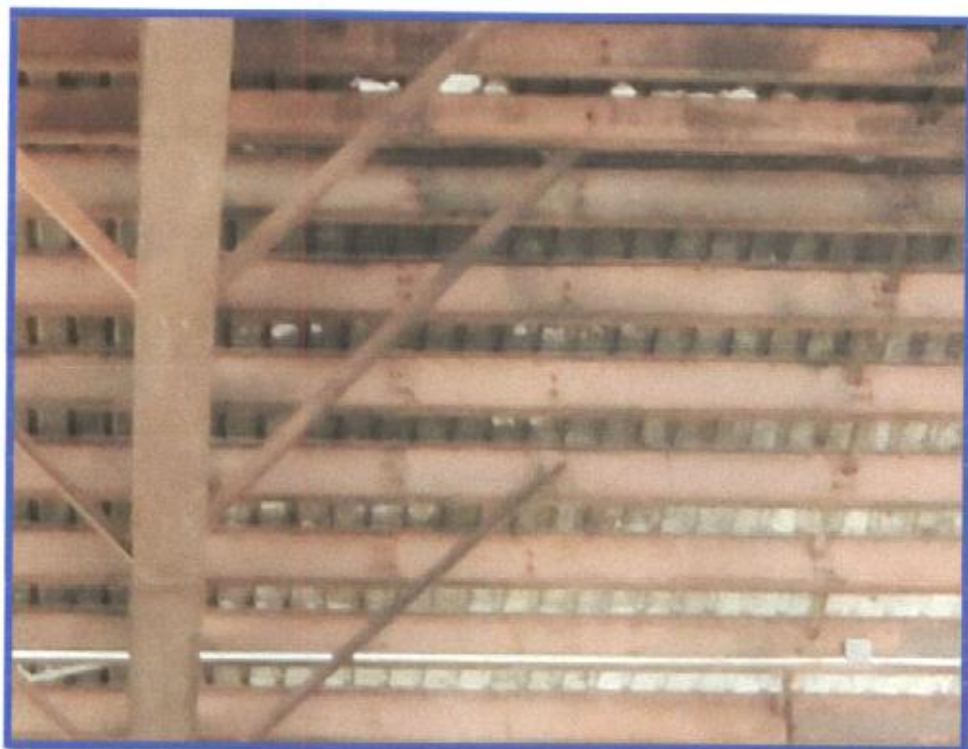
Interior documentation / Fire documentation of metal deck underside

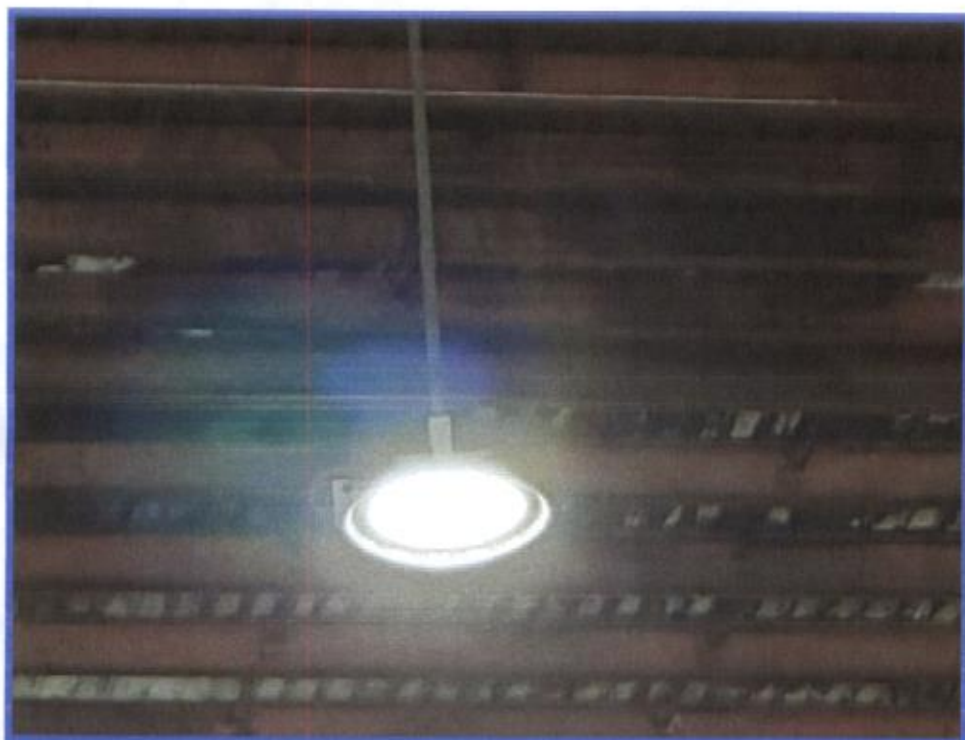
Interior documentation / Fire documentation of metal deck underside

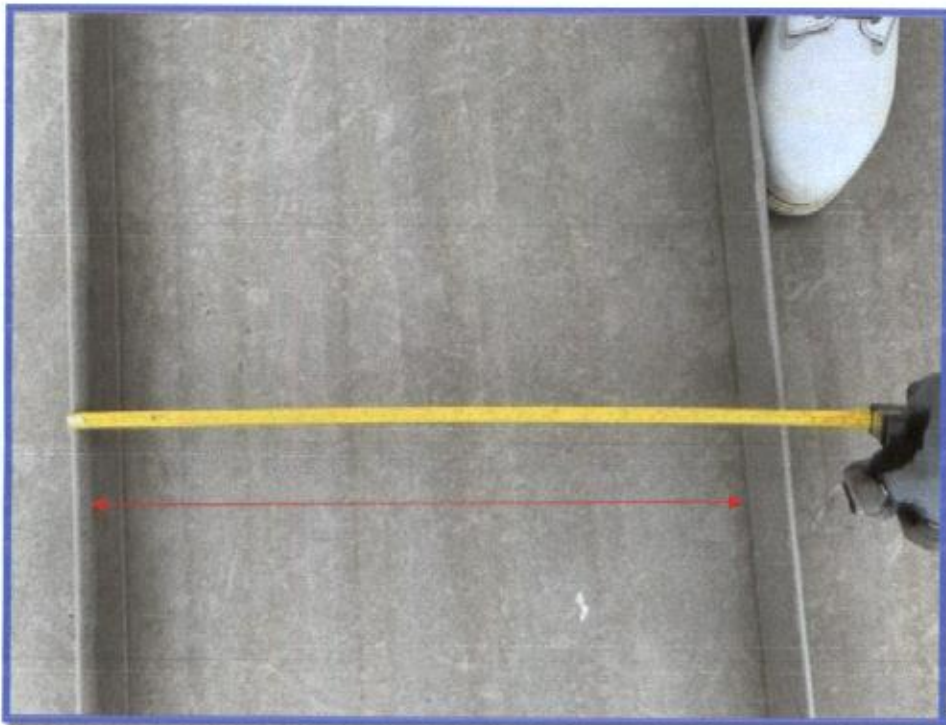
Killeen Transfer Station Panel width 22.5"

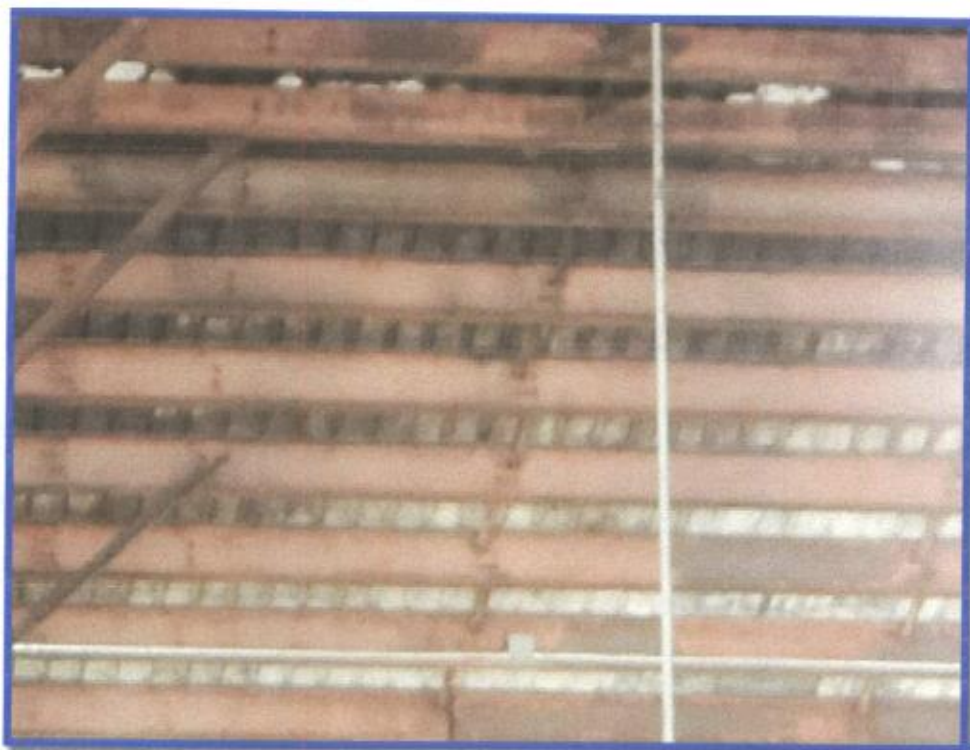
Interior documentation / Fire documentation of metal deck underside

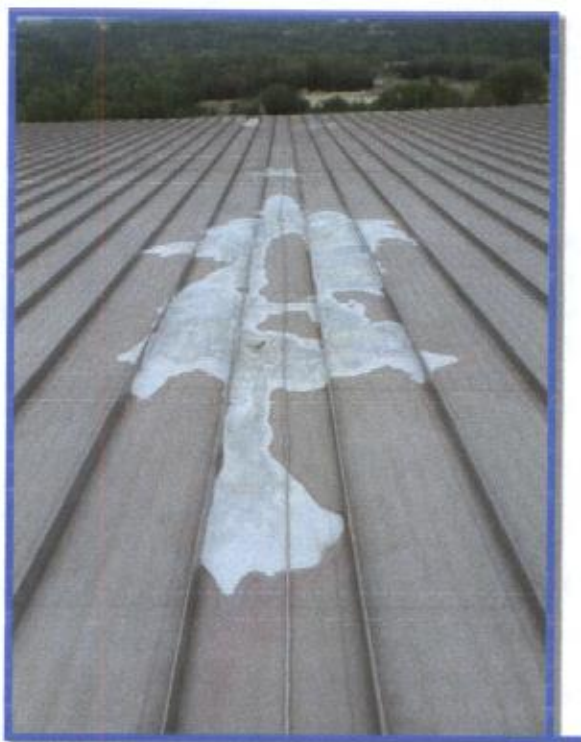
Fire damage to east Exposure / ABC (ACM) Metal Panels

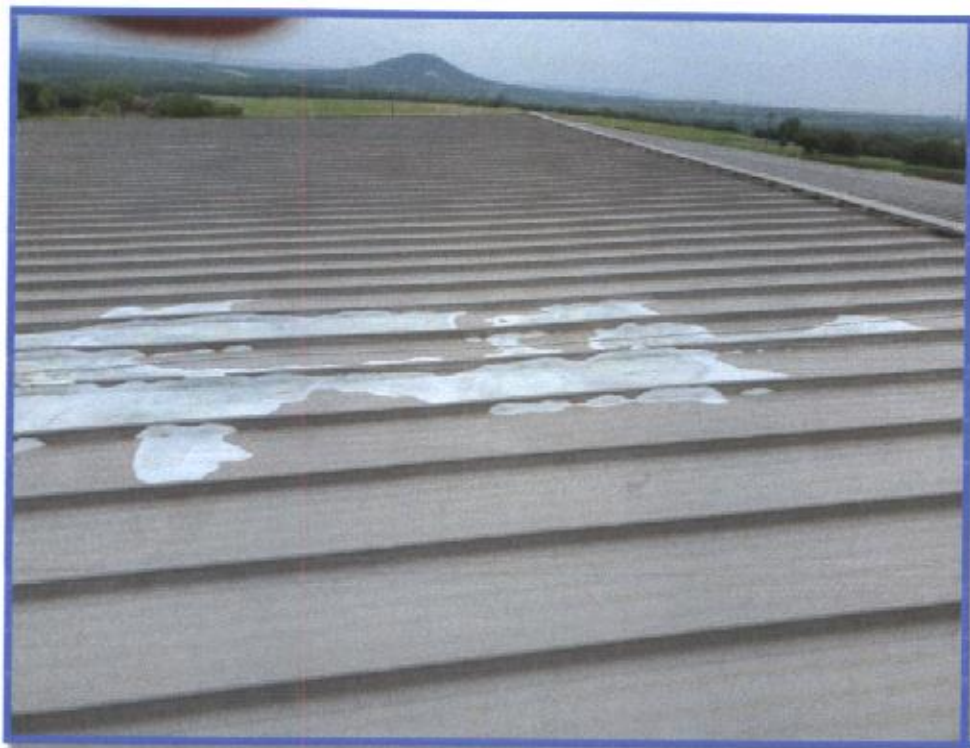
Fire Damage to East Exposure

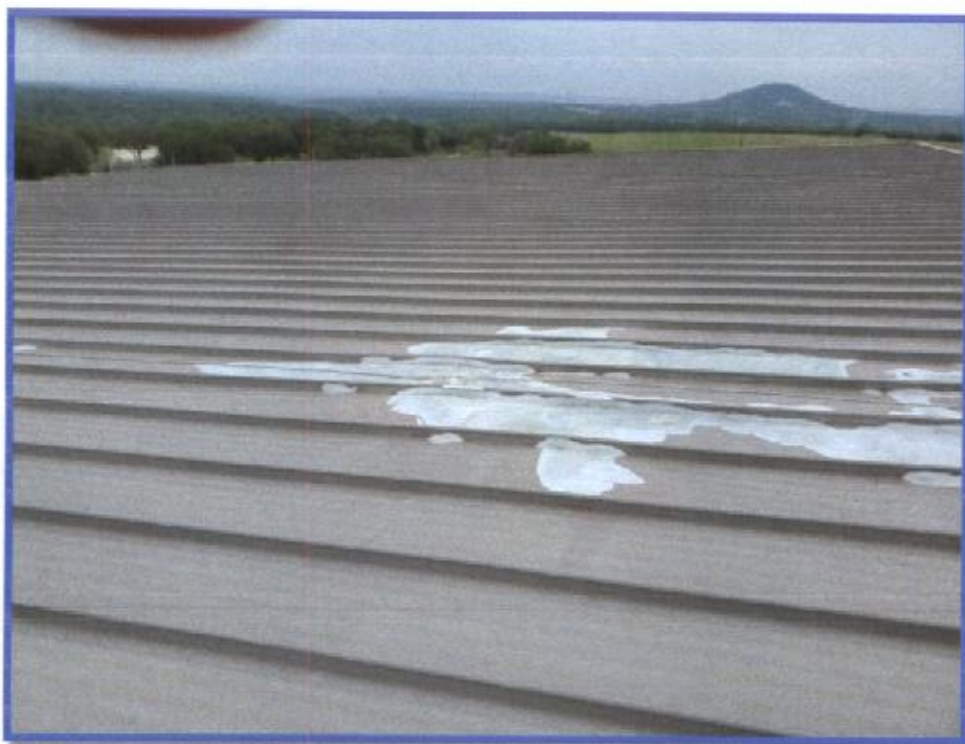
Fire Damage

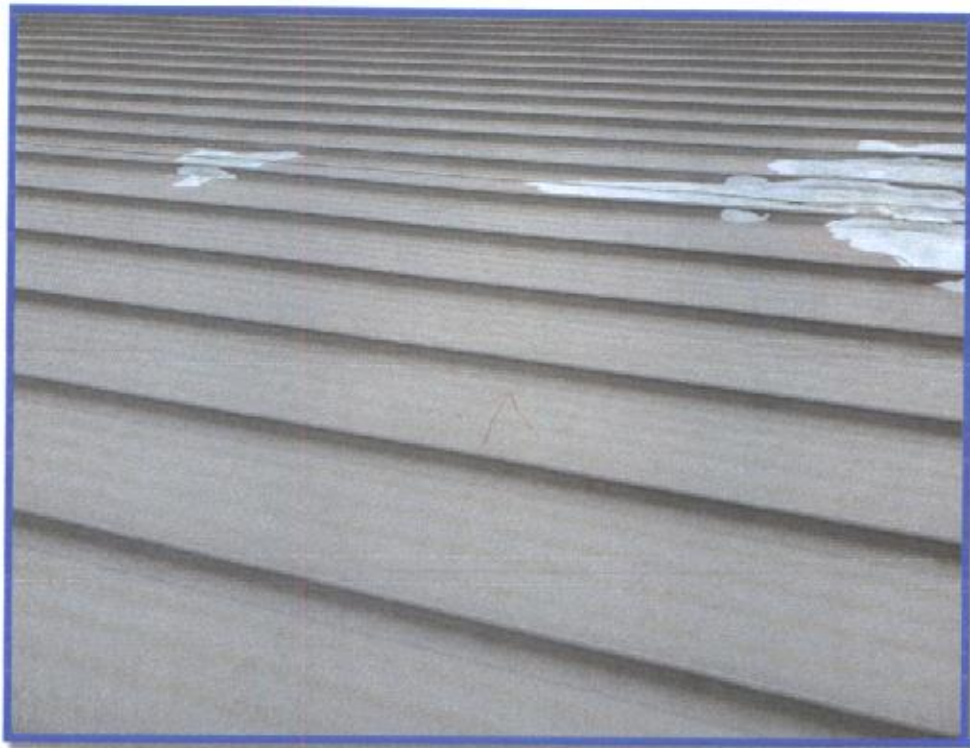
Fire Damage

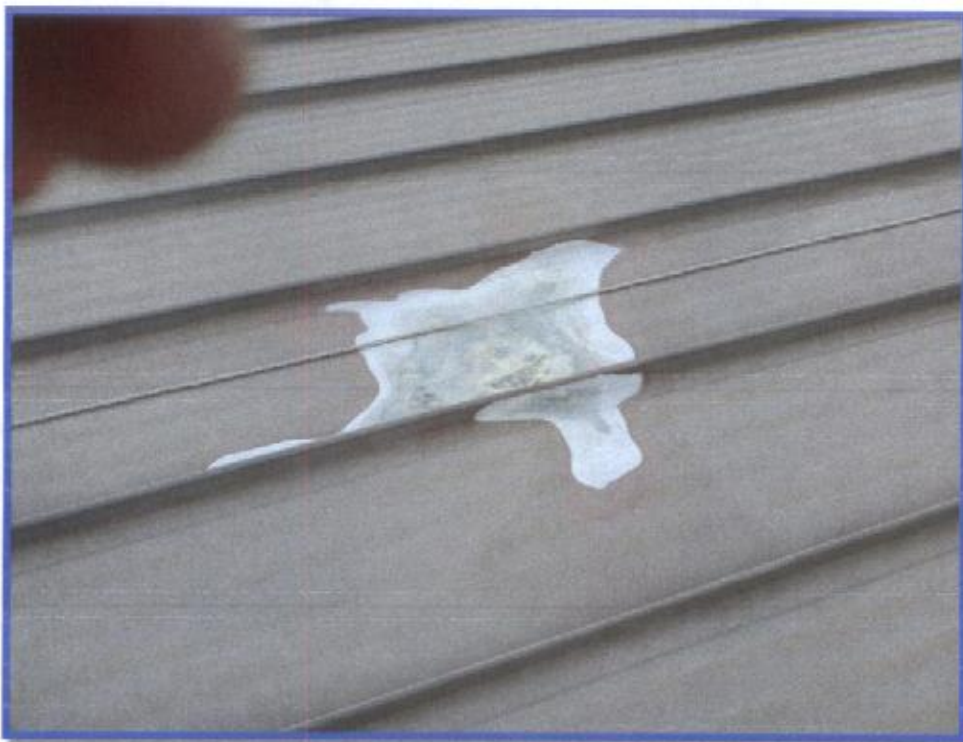
Fire Damage to Panel

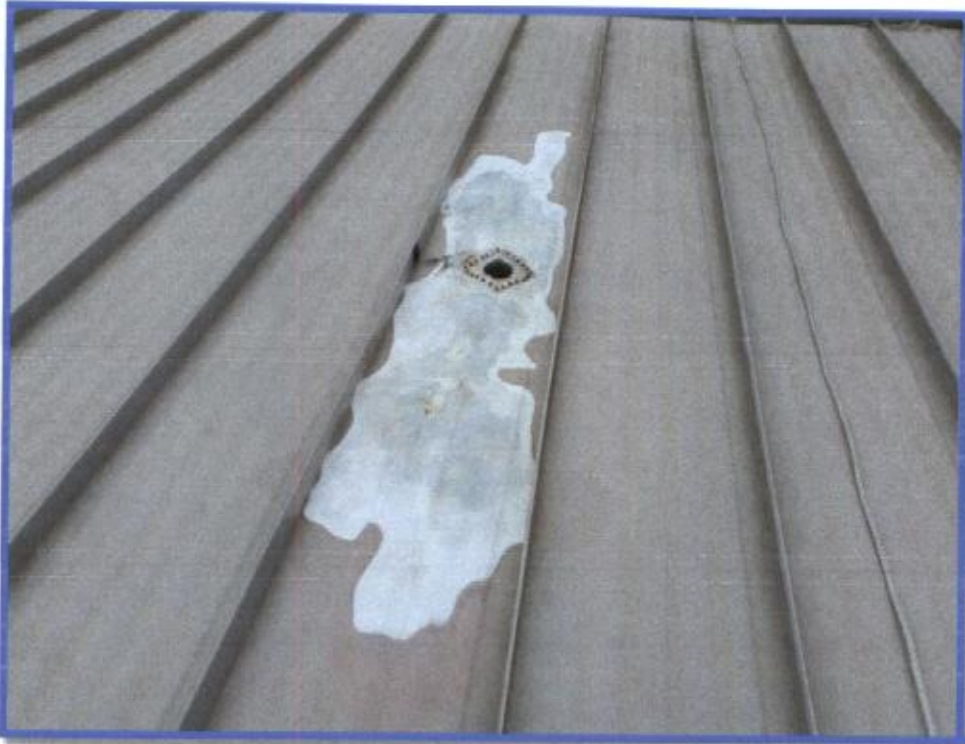
Roof Penetration at Fire location and associated damage

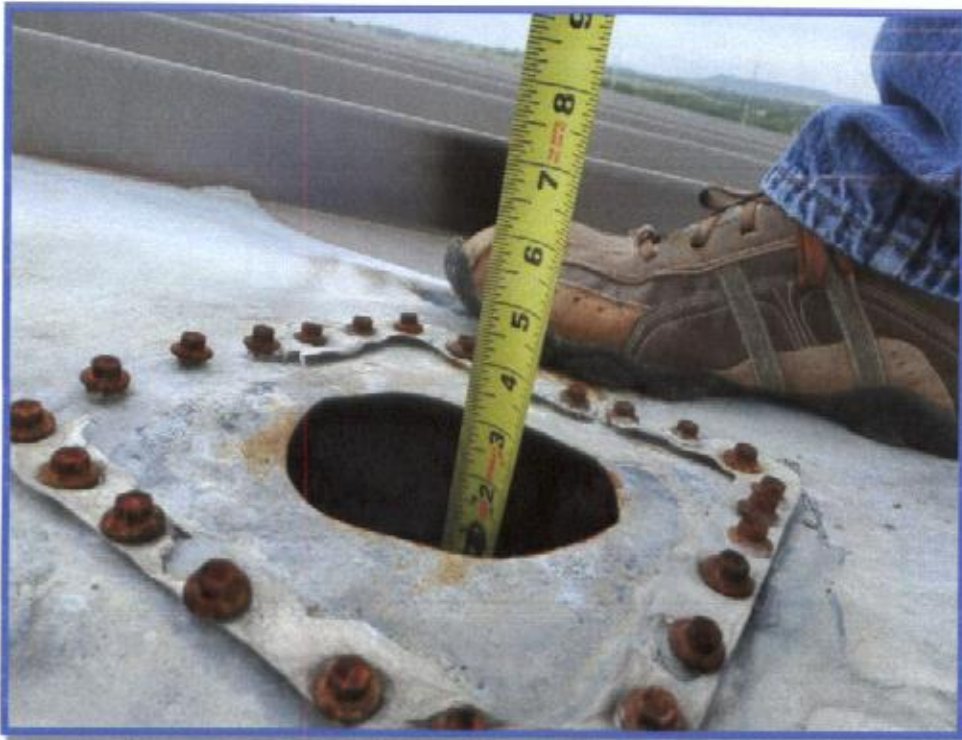
Roof Penetration at Fire location

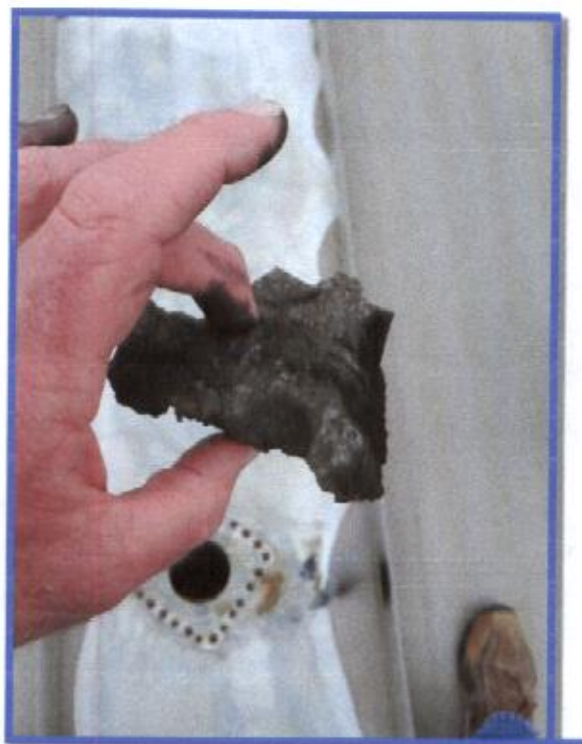
Fire damaged ISO Insulation above Fire

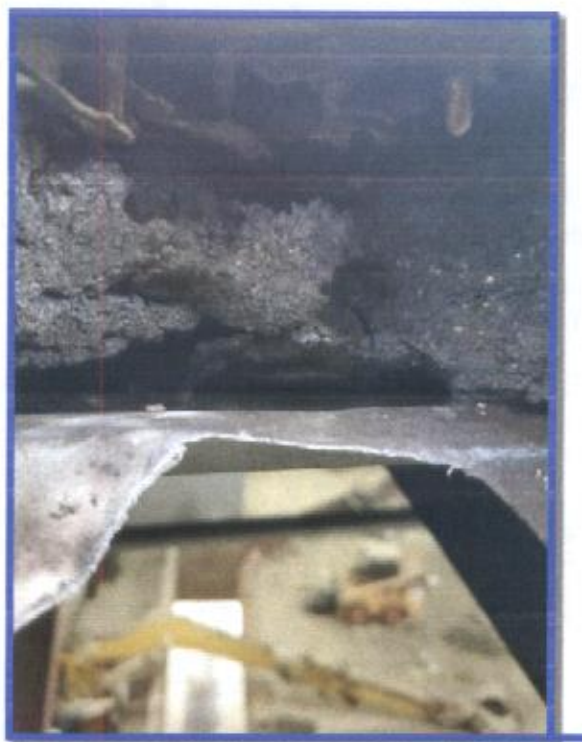
Metal Deck / Insulation and Metal Panel

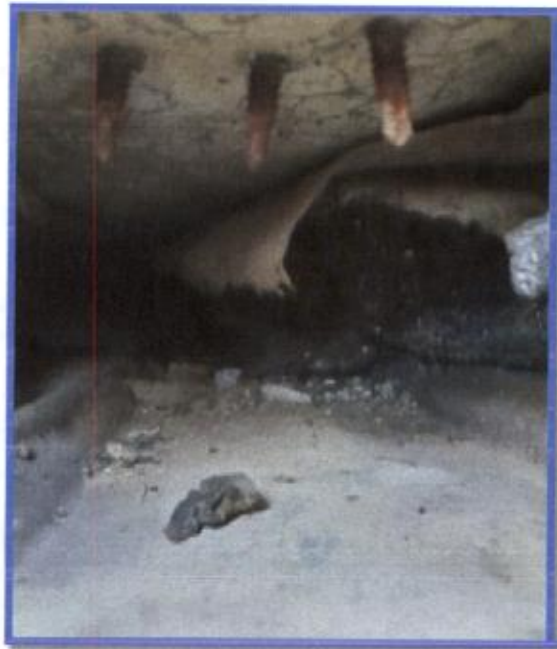
Metal deck substrate / insulation and metal (ACM) panel

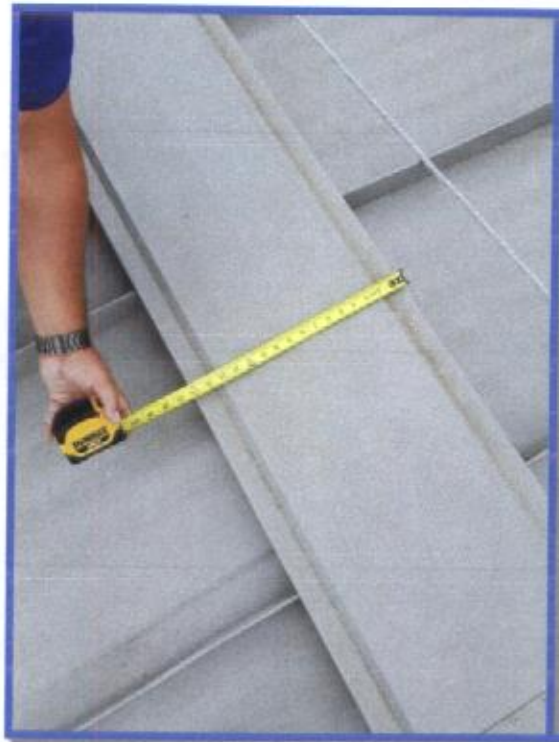
Metal Ridge documentation

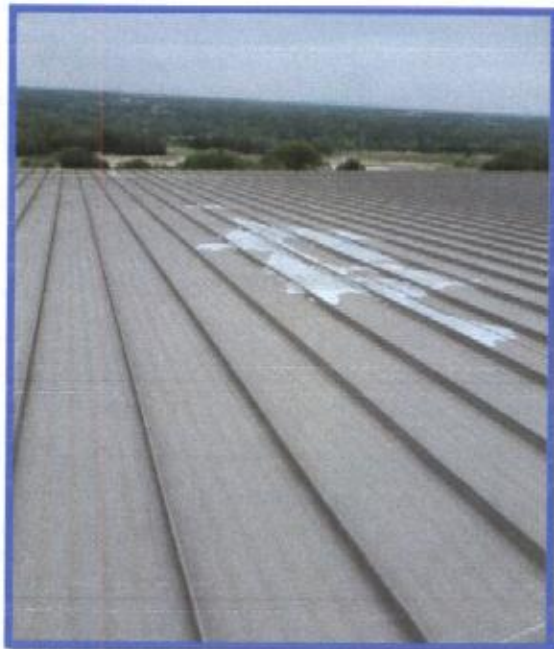
KILLEEN / TRANSFER STATION / PANELS COMPROMISED

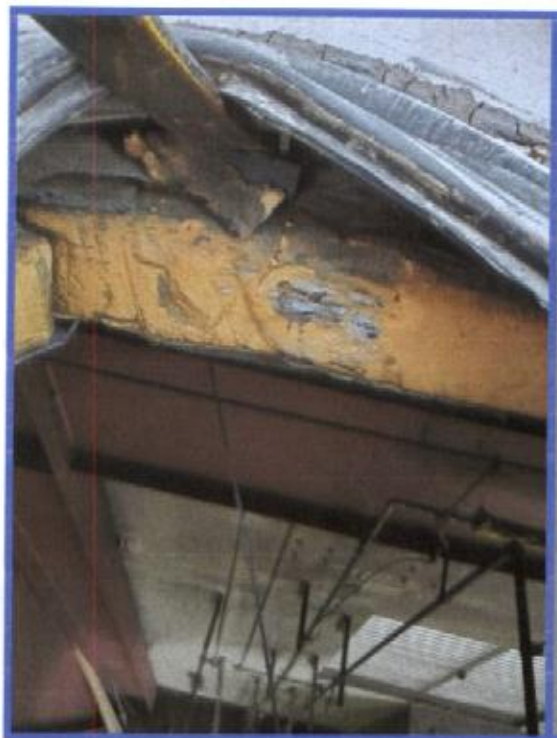
Insulation documentation

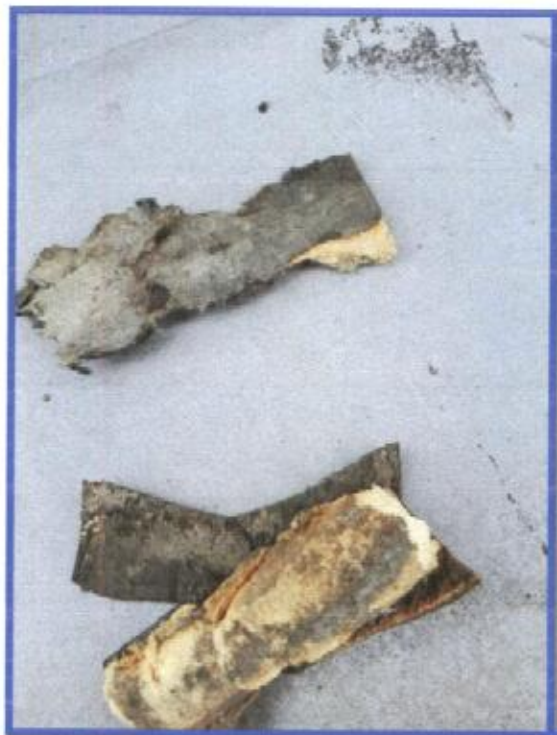
Insulation documentation

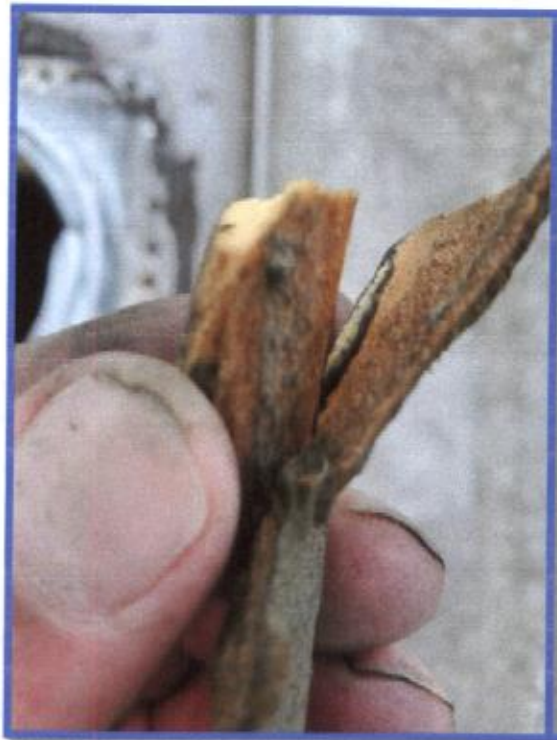
Insulation documentation
